# Elementary Schools 174-Stead Elementary School ROOF ASSESSMENT REPORT 2024

10580 Stead Blvd.  
Reno, NV 89506

# **Washoe County Schools** **174-Stead Elementary School: Reno, NV** **2025 Executive Summary**

On September 09, 2024, BTA conducted an objective survey on the roofs at 174-Stead Elementary School in Reno, NV.

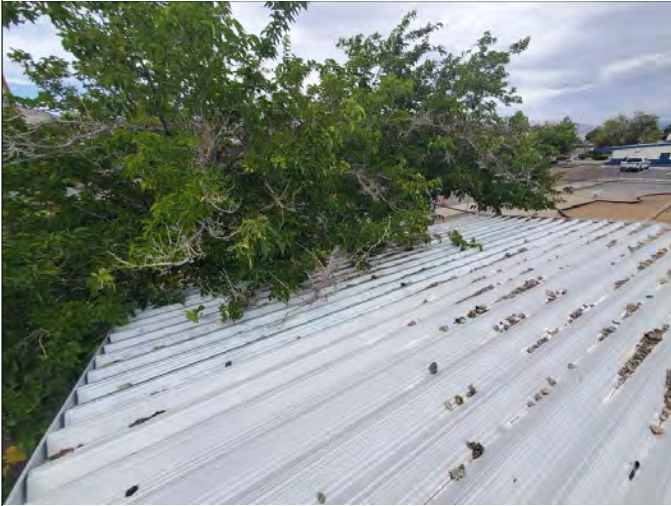
Photo #: 01

Trees Overhanging Roof Area

| Code | Description | Quantity | Action |
|---|---|---|---|
| XX1 | Trees/Vegetation Overhanging Roof | 100sf | No Work |
| Z4 | Vegetation/Debris on roof | 800sf | Reconstructive |

- a. Remove and dispose of debris, vegetation, and silt and dirt accumulations.
