# Elementary Schools

## 174-Stead Elementary School

### ROOF ASSESSMENT REPORT

10580 Stead Blvd.  
Reno, NV 89506

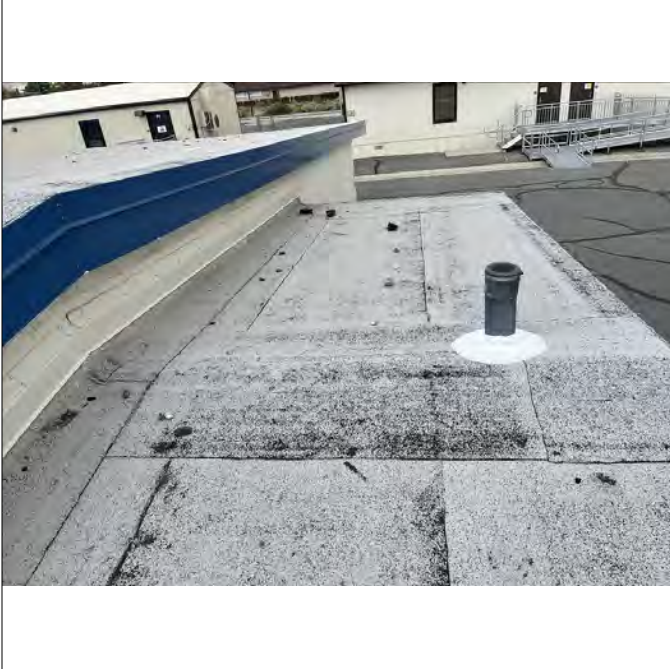
Photo #: 07

Deteriorated Surfacing

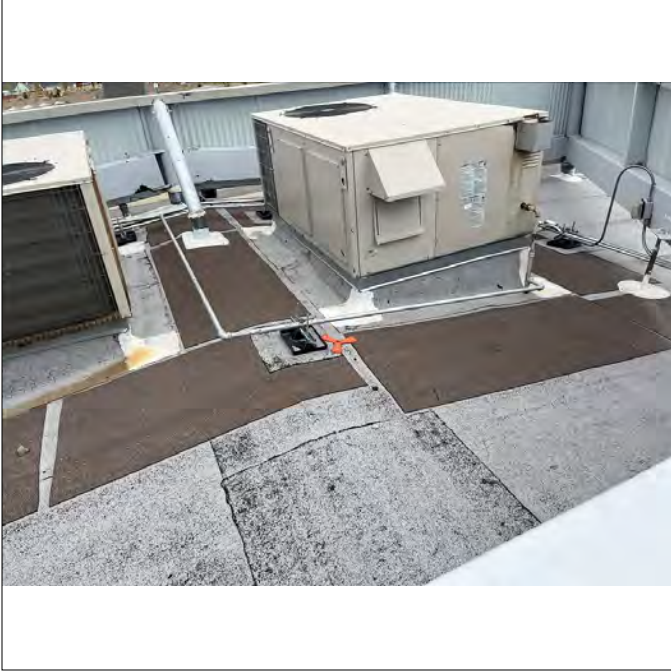
Photo #: 09

Overview of Roof Area

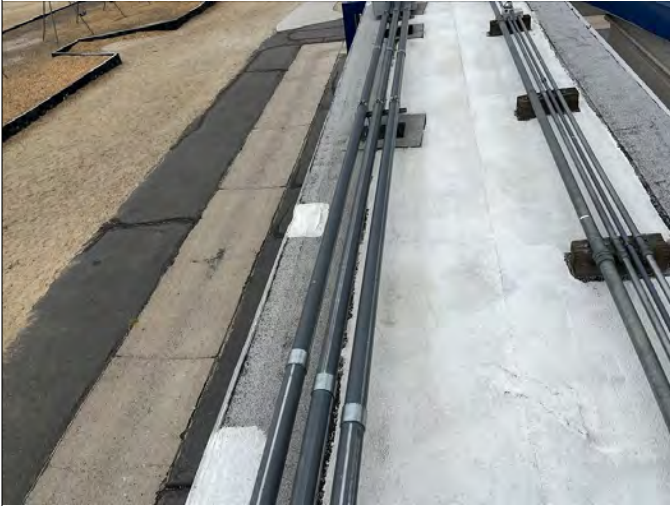
Photo #: 08

Overview of Roof Area

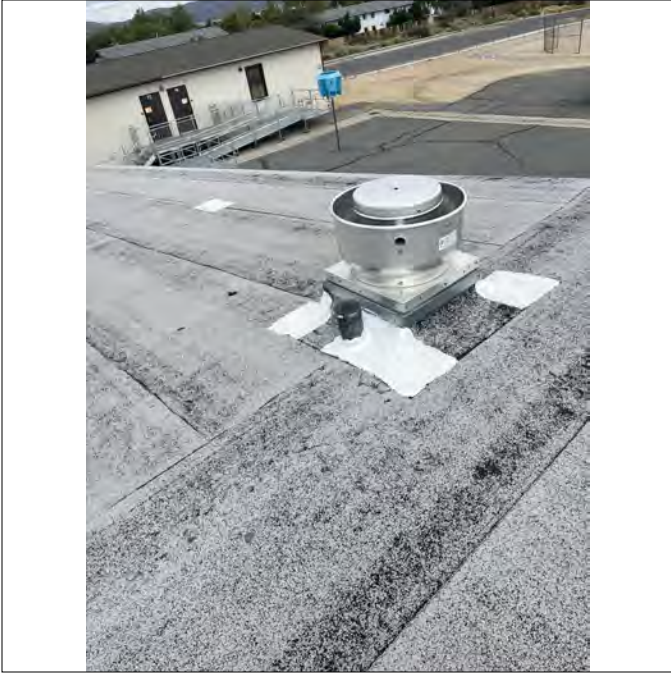
Photo #: 06

Overview of Roof Area

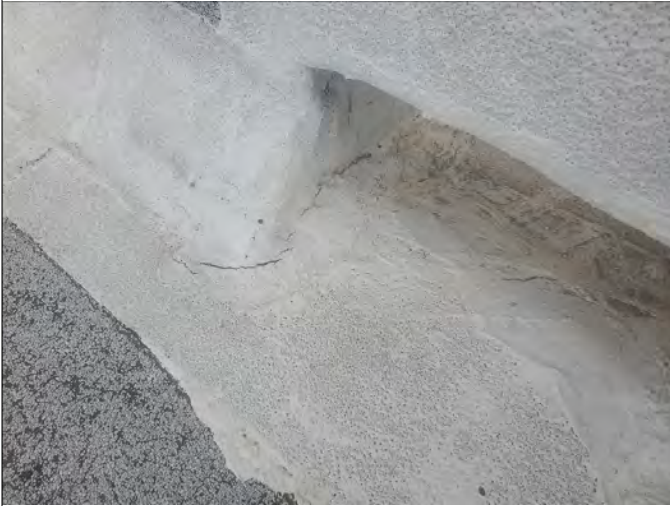
Photo #: 02

Base Flashing Split

| Code | Description | Quantity | Action |
|---|---|---|---|
| B1 | Flashing or sleeve hole, split, or tear caused by deterioration | 10 lf | No Work |

| Roof Area | Subsystem | Size(SF) | Age | SE | ASE | Recommendation | Cost |
|---|---|---|---|---|---|---|---|
| E | BUILT-UP | 2,375 | 28 | 1 | 1 | Replace | \$ 80,059 |

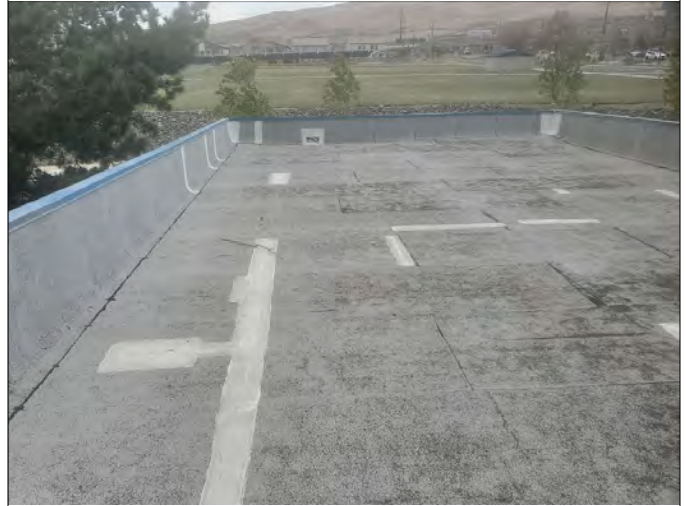
Photo #: 03

Overview of Roof Area

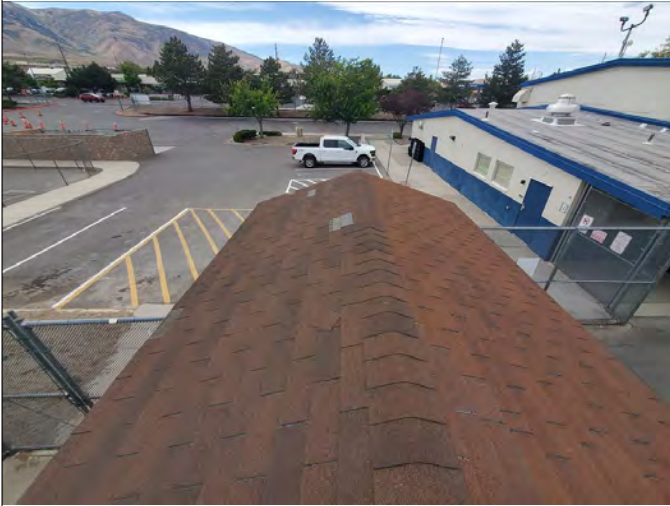
Photo #: 04

Shingle Damage

| Code | Description | Quantity | Action |
|---|---|---|---|
| T1 | Hole, cracked, split, broken or tab or shingle missing | 4 sf | No Work |
| T6 | Deteriorated—asphalt exposed (%) | 20ea | No Work |

| Roof Area | Subsystem | Size(SF) | Age | SE | ASE | Recommendation | Cost |
|---|---|---|---|---|---|---|---|
| J | SHINGLE | 165 | 30 | 1 | 1 | Replace | \$ 7,690 |

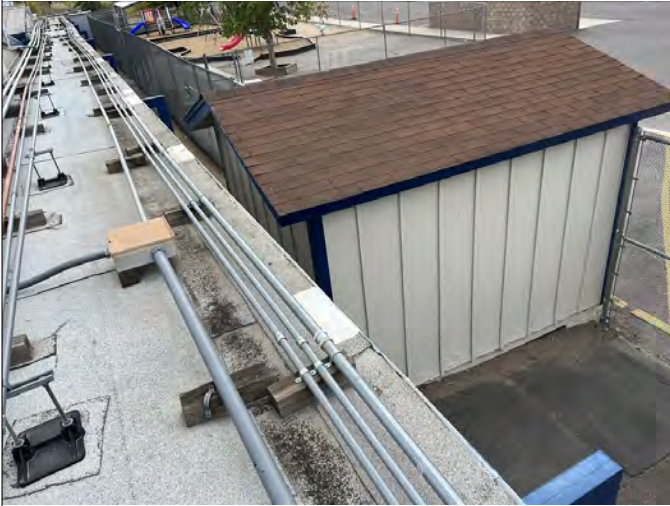
Photo #: 10

Overview of Roof Area
