ASBESTOS HAZARD EMERGENCY RESPONSE ACT

MANAGEMENT PLAN

Stead Elementary

Washoe County School District

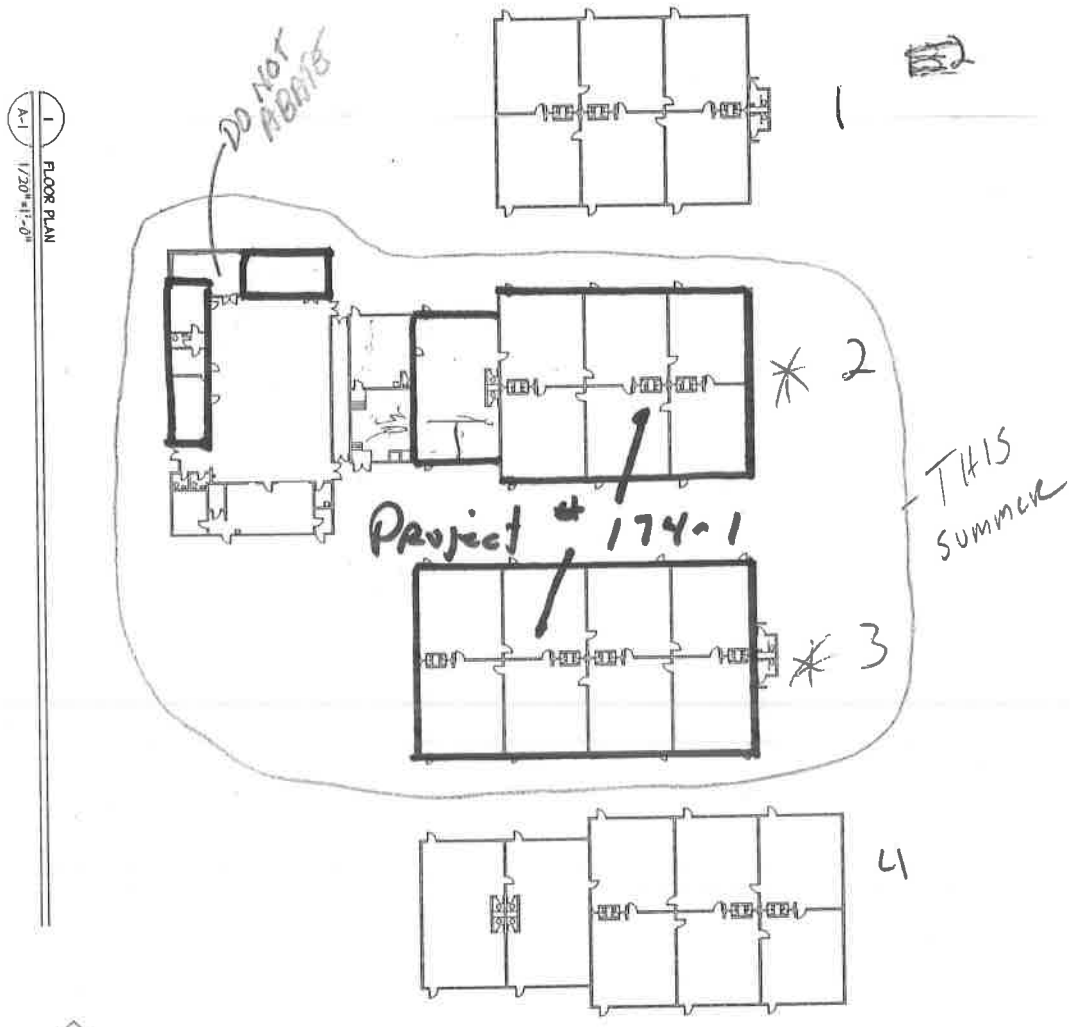
Description: Abated ACM Flooring Materials

Location of Abatement: Office Area and B & C Wing Classrooms

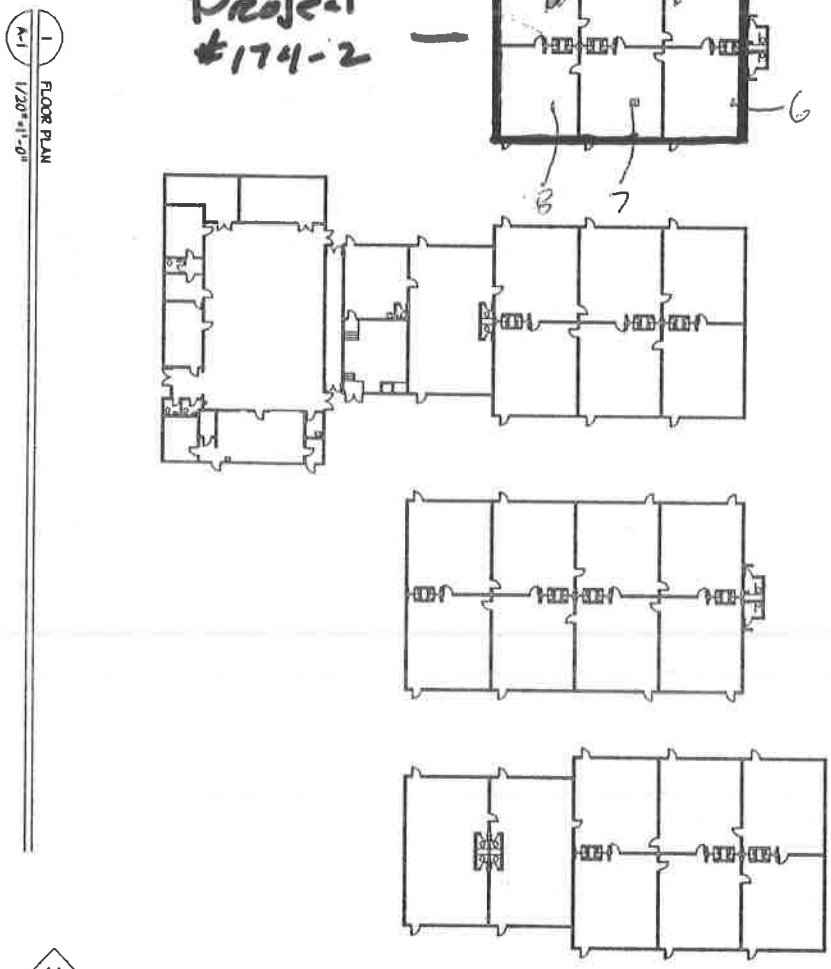
Description: Abated ACM Flooring Materials

Location of Abatement: A Wing Classrooms

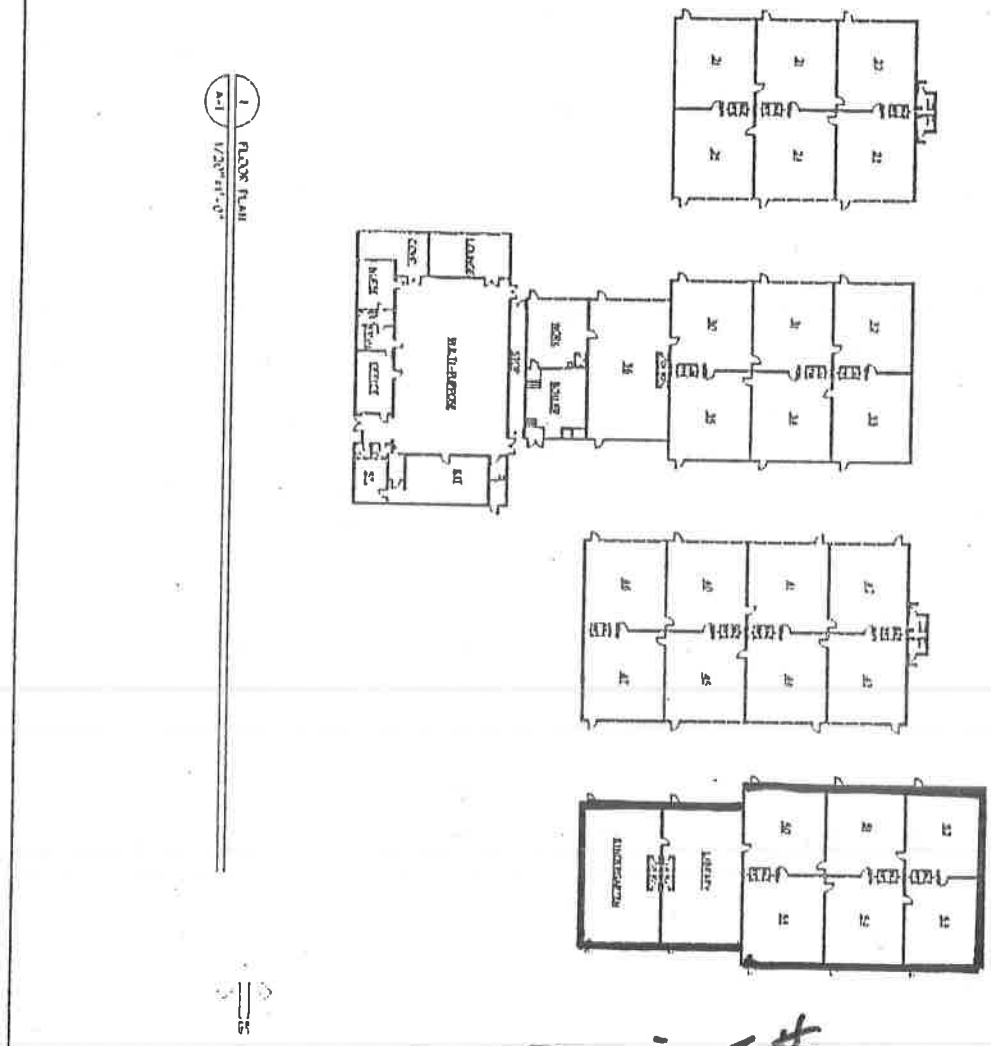
Description: Abated ACM Flooring Materials

Location of Abatement: E Wing Classrooms

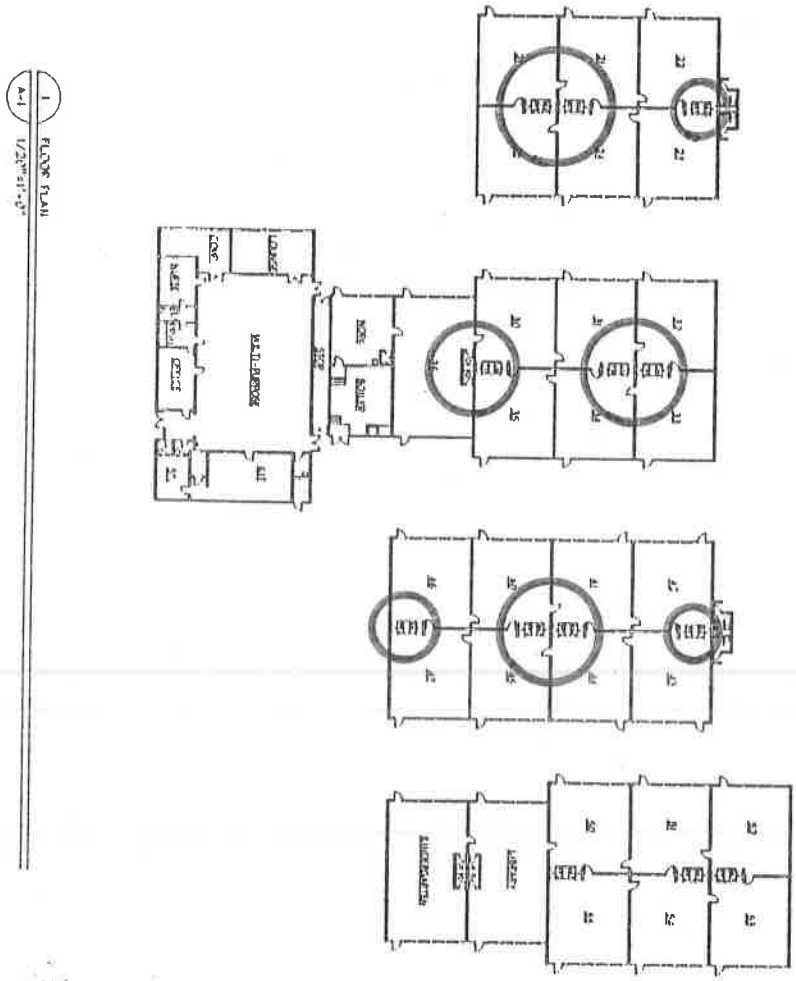
Location of Abatement: Classroom Restrooms

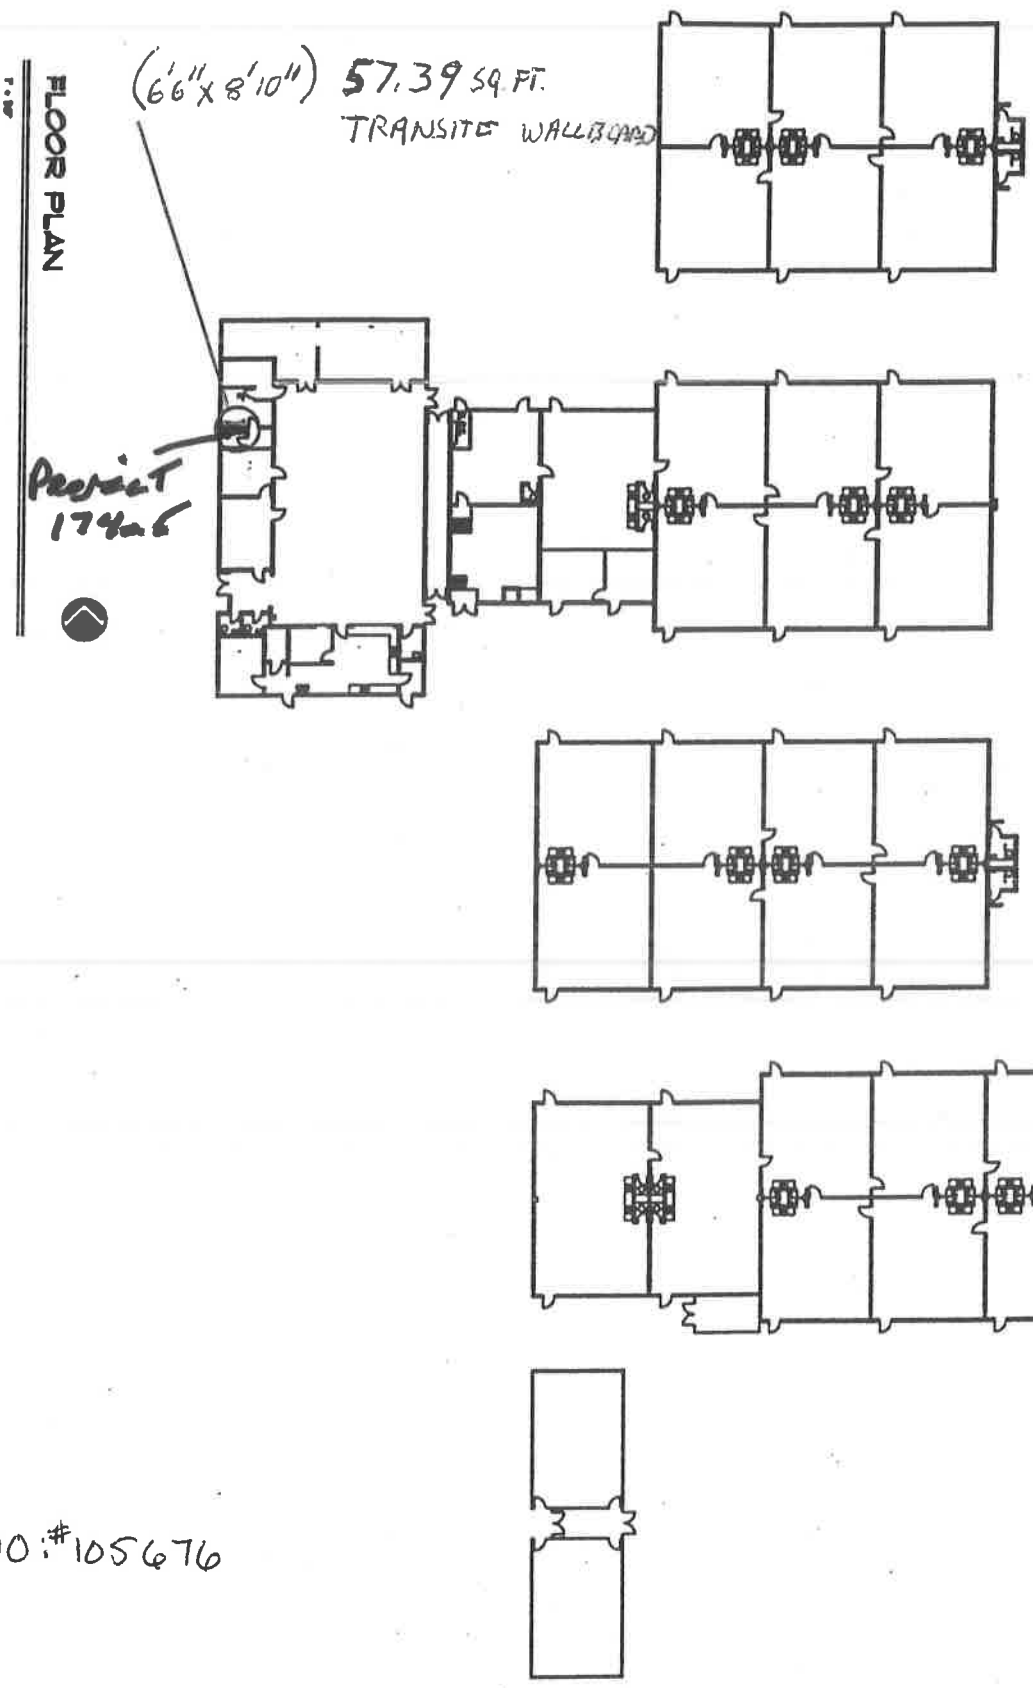
Location of Abatement: Clinic Restroom

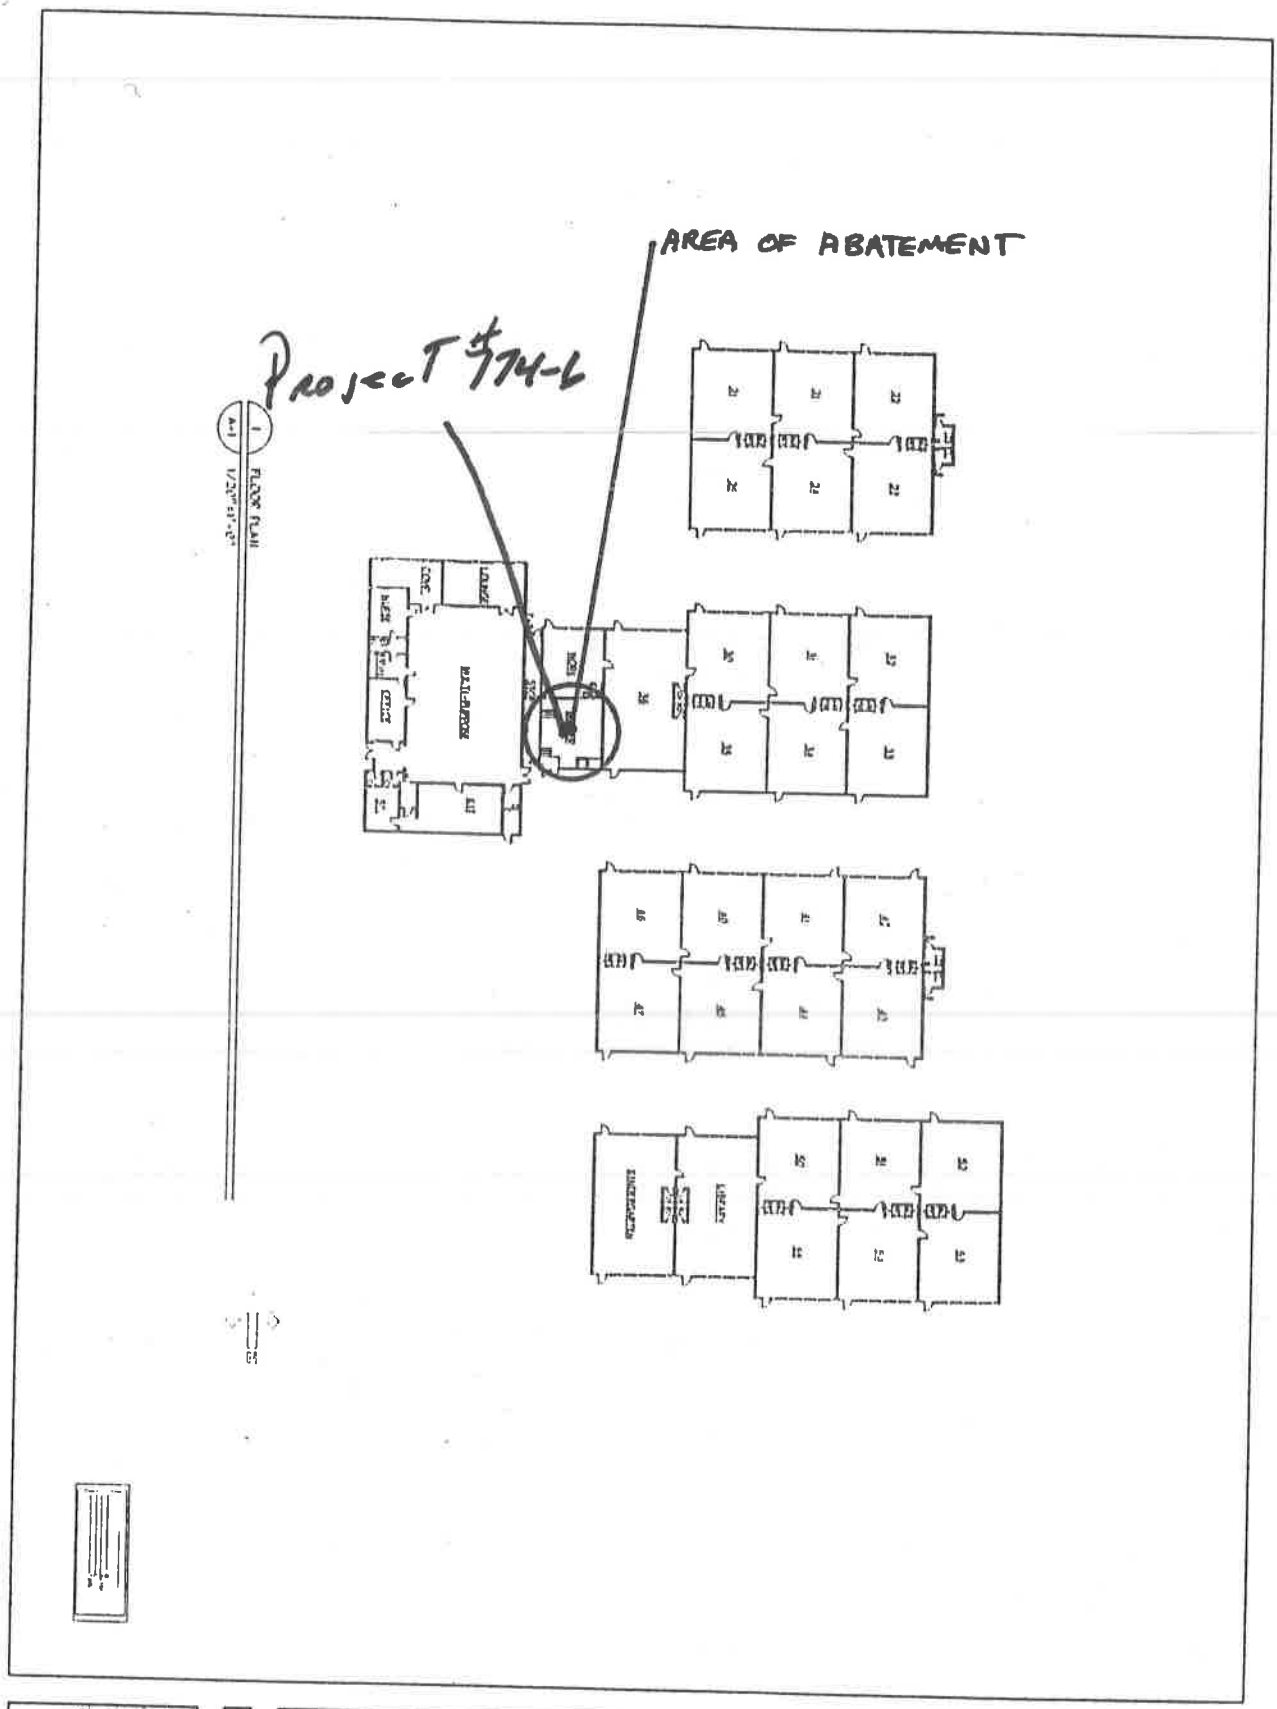
Description: Abated TSI

Location of Abatement: Boiler Room

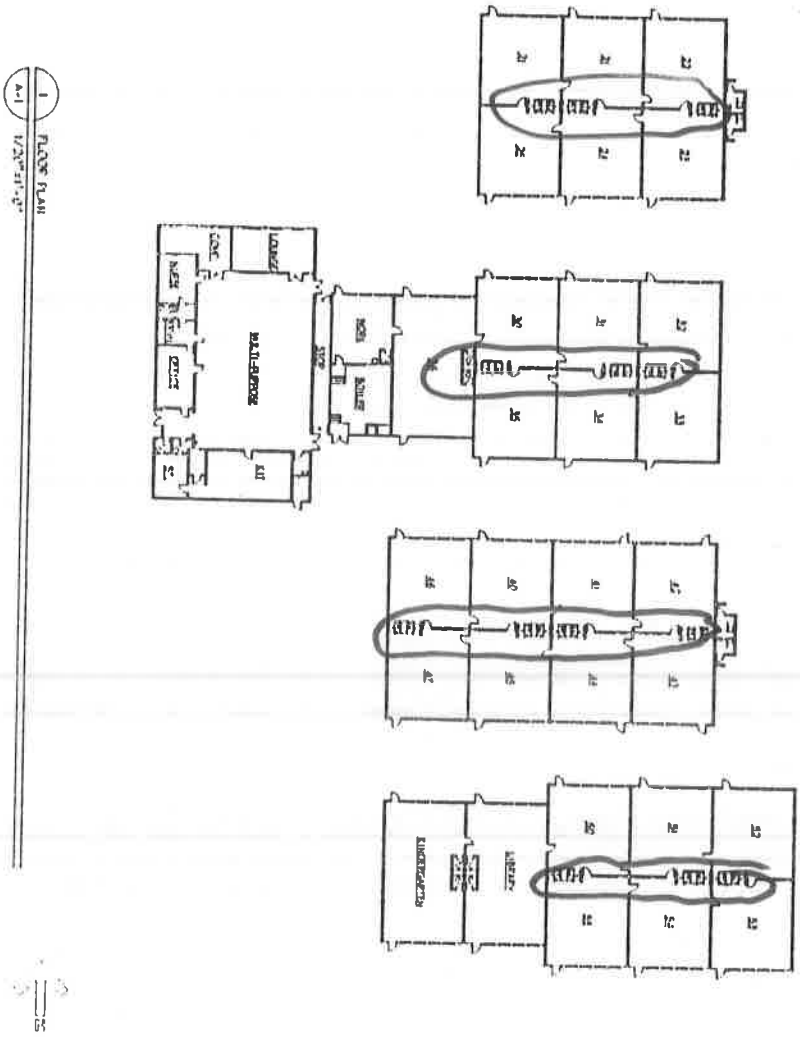
Location of Abatement: Attics Areas

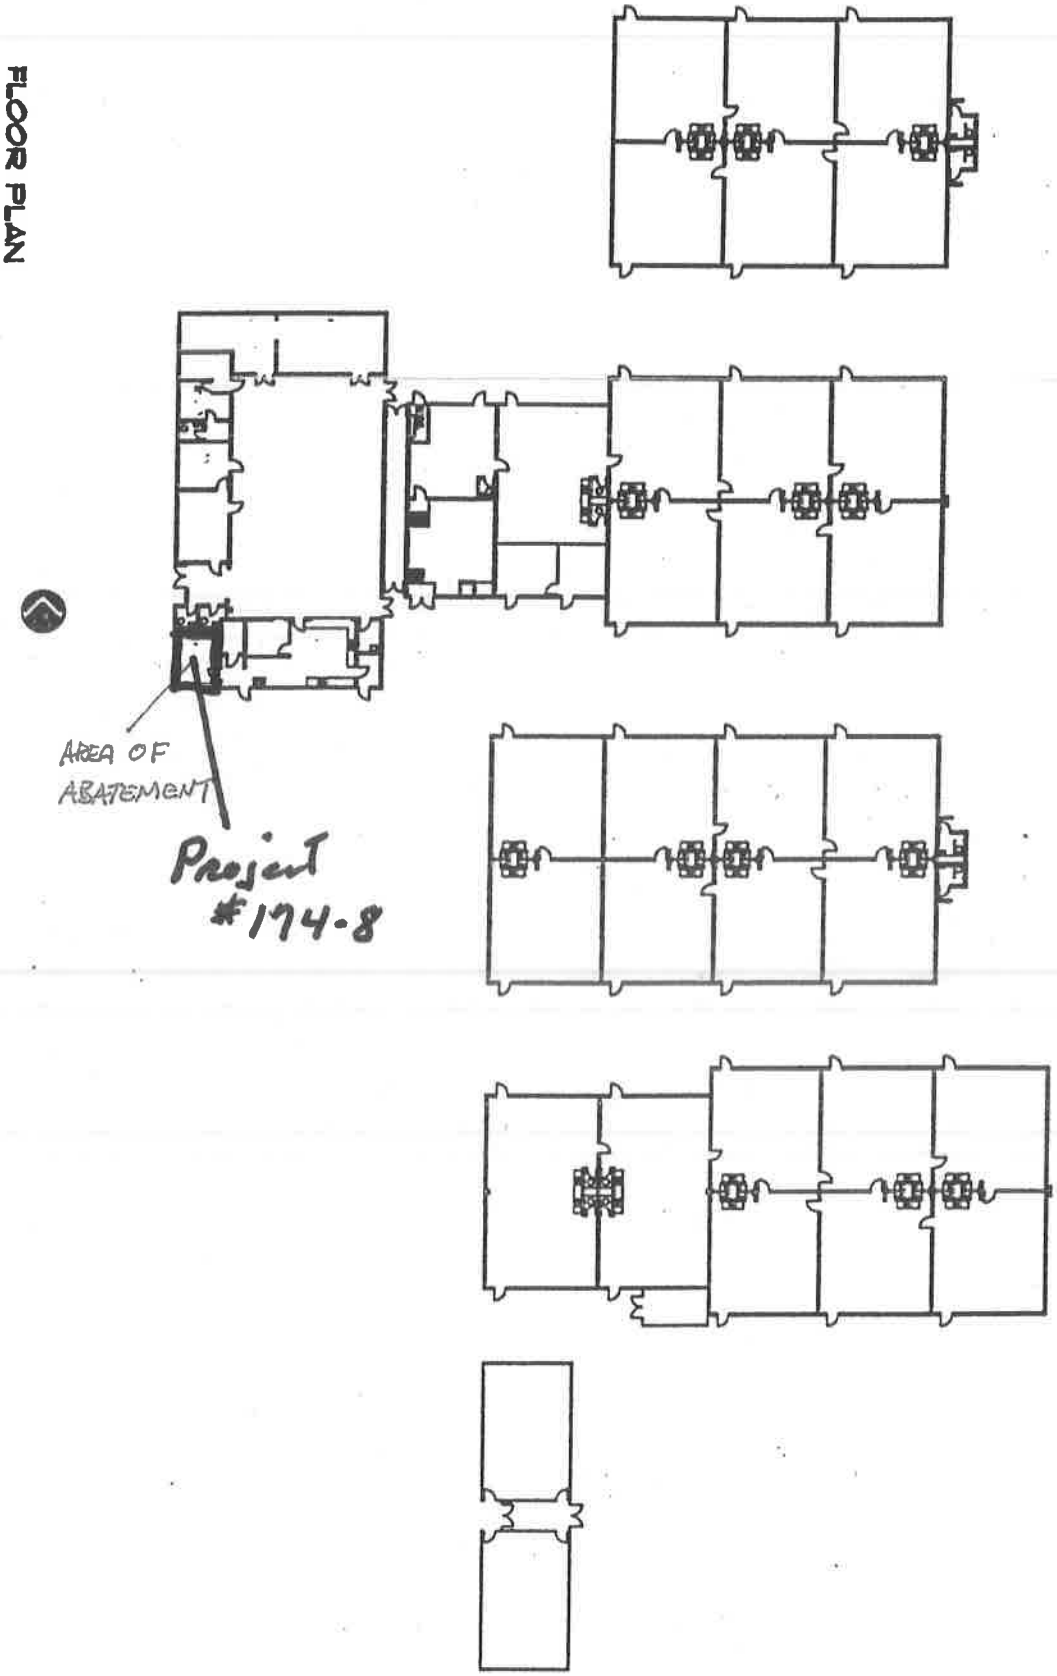
Location of Abatement: Rms #7G and #7B

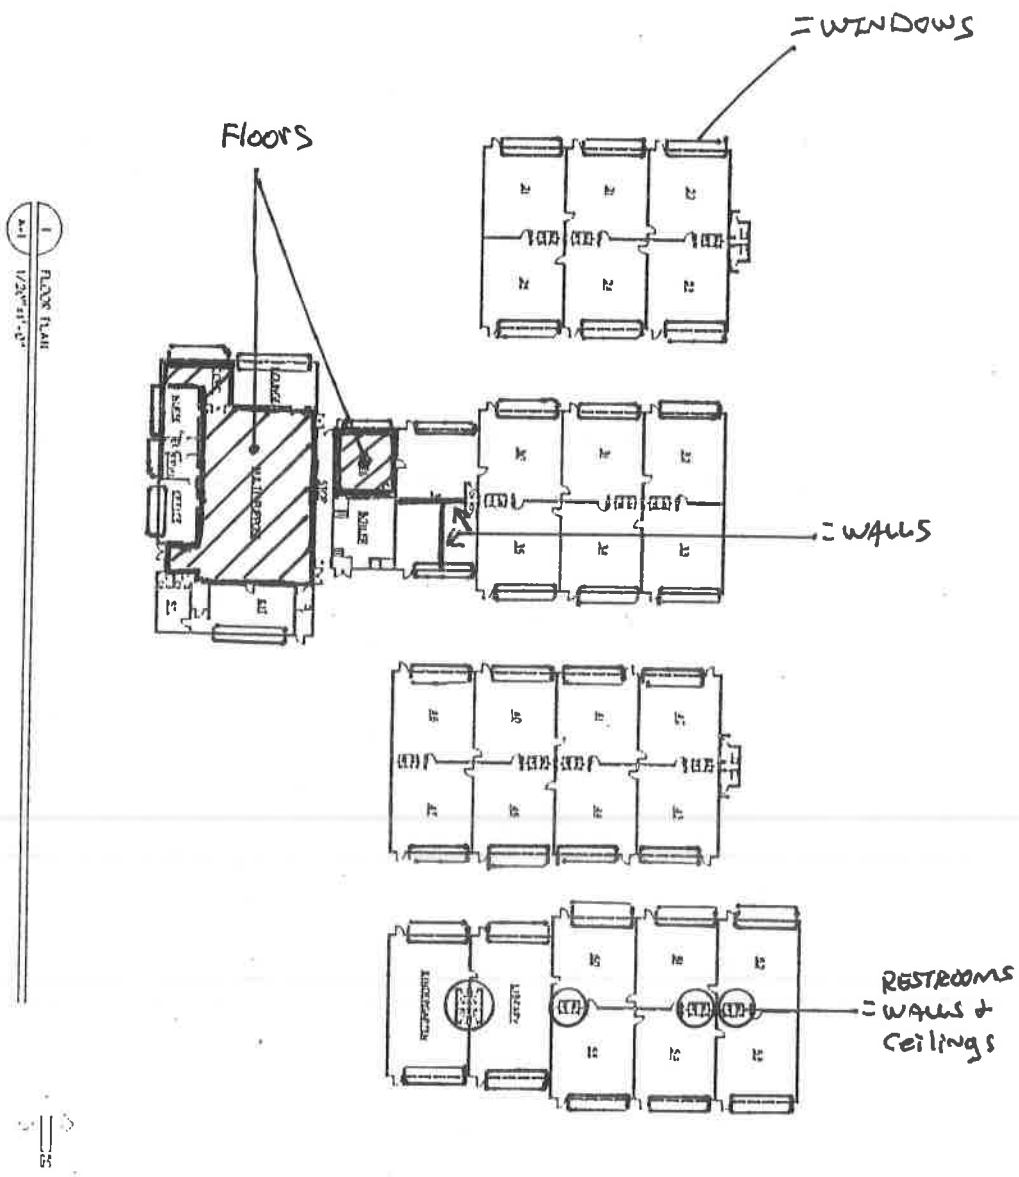
Location of Abatement: Throughout School
