# Elementary Schools 174-Stead Elementary School ROOF ASSESSMENT REPORT 2024

10580 Stead Blvd.  
Reno, NV 89506

# **Washoe County Schools** **174-Stead Elementary School: Reno, NV** **2025 Executive Summary**

On September 09, 2024, BTA conducted an objective survey on the roofs at 174-Stead Elementary School in Reno, NV.

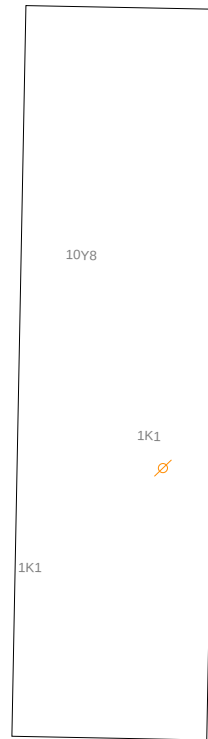
A1

| Code | Description | Quantity | Action |
|---|---|---|---|
| K1 | Non-metal flashing repair - existing | 2 If | No Work |
| Y8 | Missing Granules - Widespread Percentage | 10ea | No Work |

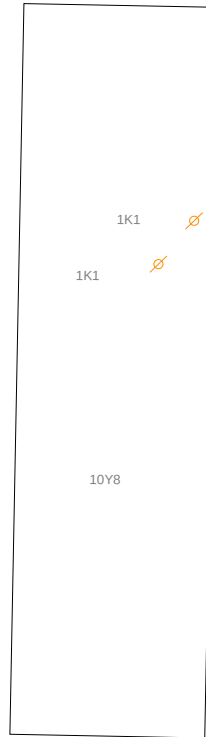
C1

| Code | Description | Quantity | Action |
|---|---|---|---|
| K1 | Non-metal flashing repair - existing | 2 lf | No Work |
| Y8 | Missing Granules - Widespread Percentage | 10ea | No Work |

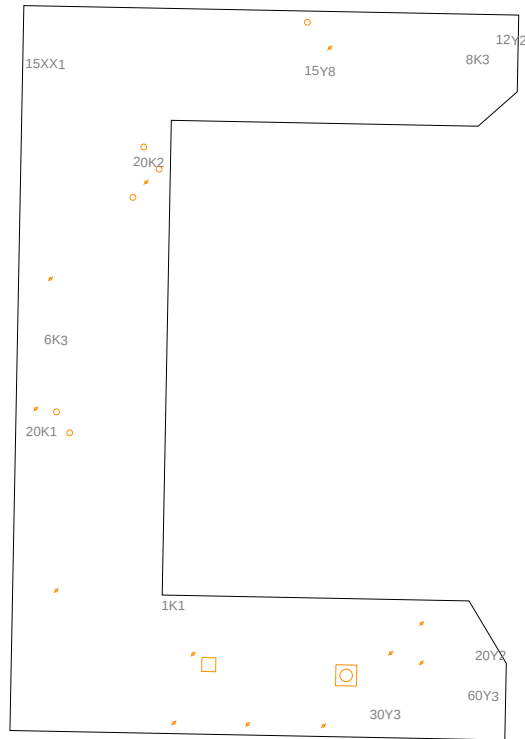
D1

| Code | Description | Quantity | Action |
|---|---|---|---|
| K1 | Non-metal flashing repair - existing | 21 lf | No Work |
| K2 | Metal flashing repair - existing | 20 lf | No Work |
| K3 | Roof membrane repair - existing | 14 sf | No Work |
| Y2 | Deteriorated surfacing--top felt exposed | 32 sf | No Work |
| Y3 | Deteriorated surfacing--no exposed felt | 90 sf | No Work |
| Y8 | Missing Granules - Widespread Percentage | 15ea | No Work |

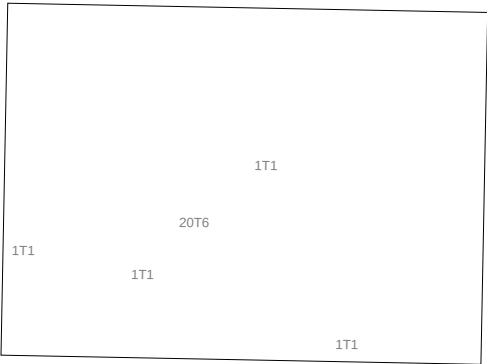
| Code | Description | Quantity | Action |
|---|---|---|---|
| T1 | Hole, cracked, split, broken or tab or shingle missing | 4 sf | No Work |
| T6 | Deteriorated—asphalt exposed (%) | 20ea | No Work |
