# Elementary Schools

## 174-Stead Elementary School

### ROOF ASSESSMENT REPORT

10580 Stead Blvd.  
Reno, NV 89506

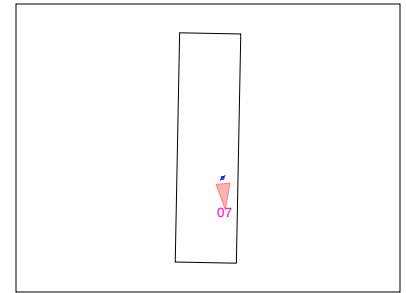
Photo #: 07

Deteriorated Surfacing

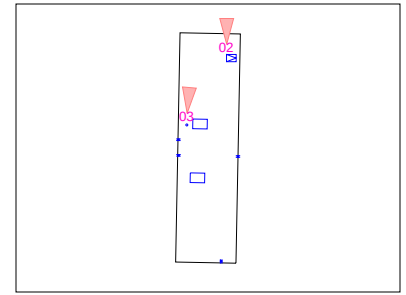
Photo #: 02

| Roof Area | Subsystem | Size(SF) | Age | SE | ASE | Recommendation | Cost |
|---|---|---|---|---|---|---|---|
| E | BUILT-UP | 2,375 | 28 | 1 | 1 | Replace | \$ 80,059 |

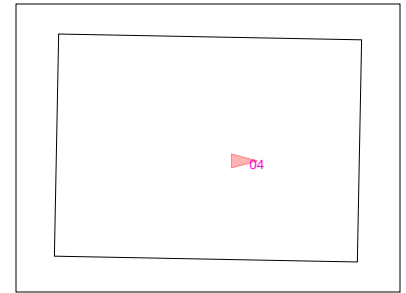
Photo #: 04

Shingle Damage

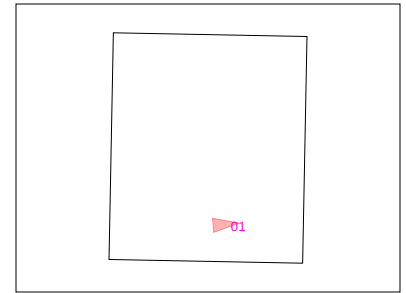
Photo #: 01

| Roof Area | Subsystem | Size(SF) | Age | SE | ASE | Recommendation | Cost |
|---|---|---|---|---|---|---|---|
| K | PANEL | 492 | 35 | 2 | 10 | Repairs | \$ 3,402 |

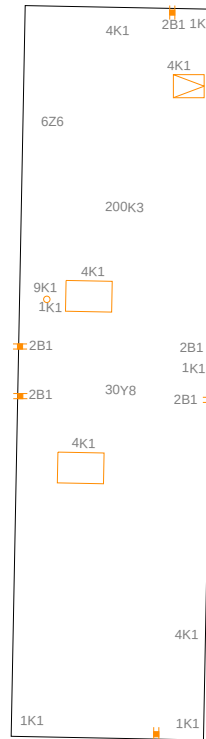
E

| Code | Description | Quantity | Action |
|---|---|---|---|
| B1 | Flashing or sleeve hole, split, or tear caused by deterioration | 10 lf | No Work |
| K1 | Non-metal flashing repair - existing | 34 lf | No Work |
| K3 | Roof membrane repair - existing | 200 sf | No Work |
| Y8 | Missing Granules - Widespread Percentage | 30ea | No Work |

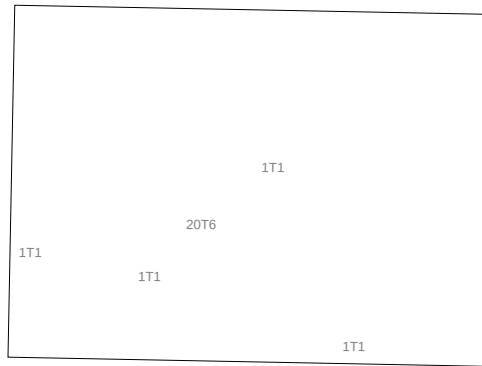
| Code | Description | Quantity | Action |
|---|---|---|---|
| T1 | Hole, cracked, split, broken or tab or shingle missing | 4 sf | No Work |
| T6 | Deteriorated—asphalt exposed (%) | 20ea | No Work |
